THESIS

ROLLING CONTACT FATIGUE TESTING OF THERMOMECHANICALLY PROCESSED M-50 STEEL

Fred A. Butterfield, III

December 1984

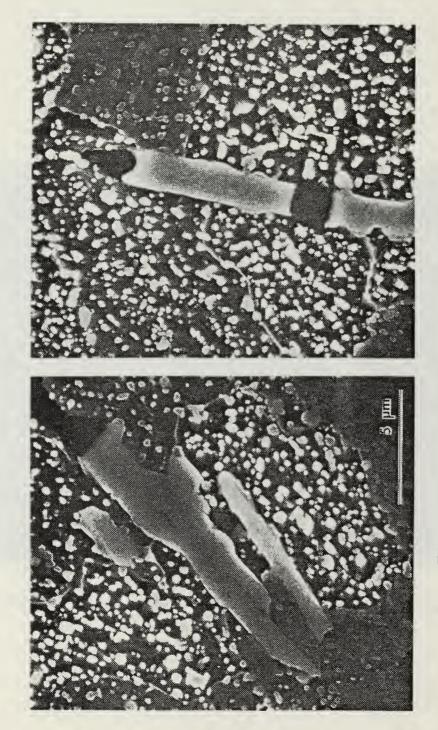
Figure 3.3 As-Received Material (6000X)

Under the scanning electron microscope at a magnification of 6000X (Figure 3.3), the as-received material exhibits the large, insoluble carbides and also the smaller temper carbides. These latter, soluble carbides are

Observe as well the small holes, or voids, at the ends of the insoluble carbides. This is cavitation which is presumably caused by the hot rolling of the steel into bar stock when manufactured. This phenomenon was observed (under the scanning electron microscope only) in virtually every sample of this material, both before and after thermomechanical processing, and regardless of the heat treatment scheme followed. Since the voids exist "in the shadow" of the insoluble carbides, their presence using optical microscopy was, understandably, not visible. It is thought that, during the rolling, the insoluble carbides behave as hard, undeformable particles in a relatively soft matrix. Thus, cavitation occurs at the ends of these residual carbides, analogous to the manner in which a high and low pressure zone exists at the upstream and downstream ends, respectively, of an obstruction in a flow stream. This is a significant finding which may have important ramifications with regard to the performance of M-50 steel in rollingelement applications, a point emphasized below in the discussion of the Weibull analysis.

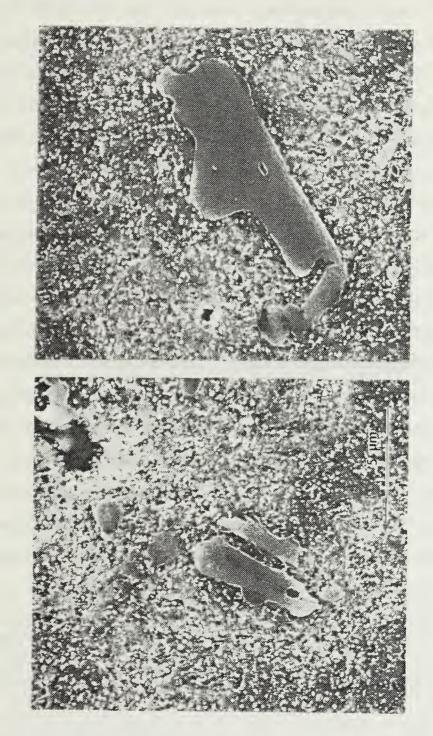
Figure 3.4 Warm-Rolled (700°C) Material (6000X)

Figure 3.4 shows the warm-rolled material at the same magnification (6000X), and there it is observed that the soluble carbides clearly have been refined in size, although there is no discernable effect upon the insoluble carbides. The temper carbides again show a fine dispersion in the matrix, with neither soluble nor insoluble carbides demonstrating a proclivity to segregate. Areas of sharp grain boundary definition are visible to a lesser extent due to the obvious refinement of the grain size. These are represented by smaller areas of varying contrast in the structure. Cavitation is again observed, although it is less pronounced than in the previous (as-received) specimens.
